**DEPARTMENT OF TRANSPORTATION**

Contract #: 04-0120F4Cty: SF/ALA Rte: 80 PM: 13.2/13.9File #: 69.28**WELDING INSPECTION REPORT****Resident Engineer:** Pursell, Gary**Address:** 333 Burma Road**City:** Oakland, CA 94607**Report No:** WIR-008562**Date Inspected:** 15-Aug-2009**Project Name:** SAS Superstructure**OSM Arrival Time:** 1900**Prime Contractor:** American Bridge/Fluor Enterprises, a JV**OSM Departure Time:** 700**Contractor:** Zhenhua Port Machinery Company, Ltd (ZPMC), Changxing Island **Location:** Shanghai, China**CWI Name:** Xu Yumin, Wang Chuangning**CWI Present:** Yes No**Inspected CWI report:** Yes No N/A**Rod Oven in Use:** Yes No N/A**Electrode to specification:** Yes No N/A**Weld Procedures Followed:** Yes No N/A**Qualified Welders:** Yes No N/A**Verified Joint Fit-up:** Yes No N/A**Approved Drawings:** Yes No N/A**Approved WPS:** Yes No N/A**Delayed / Cancelled:** Yes No N/A**Bridge No:** 34-0006**Component:** OBG & Tower**Summary of Items Observed:**

**TRIAL ASSEMBLY YARD**

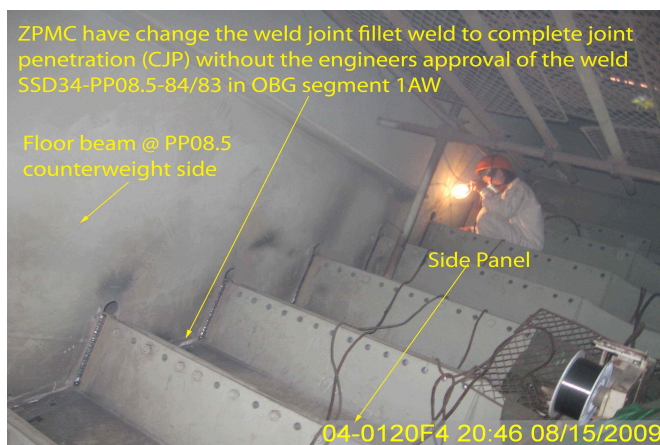
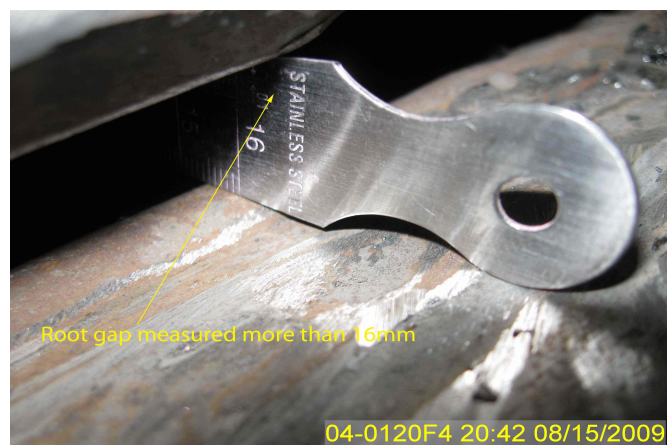
OBG SEGMENT-1AW

This Quality Assurance Inspector (QA) observed that the contractor appears to have deviated from the weld joint design specified on the approved drawings. The contractor appears to have changed the weld joint from a fillet weld to a Complete Joint Penetration (CJP) weld without the Engineers approval. The root opening was measured more than 16mm. This condition exists on weld joining floor beam to side panel on OBG segment 1AW @ panel point PP08.5 counterweight side. The weld is identified as SSD34-PP08.5-84/83. For additional information see the attached photos. Incident report was sent to task leader and other supervisor.
